Eddy Current NDT Pulsed Thermography Simulation for Defect Detection

Eddy current pulsed thermography ECPT

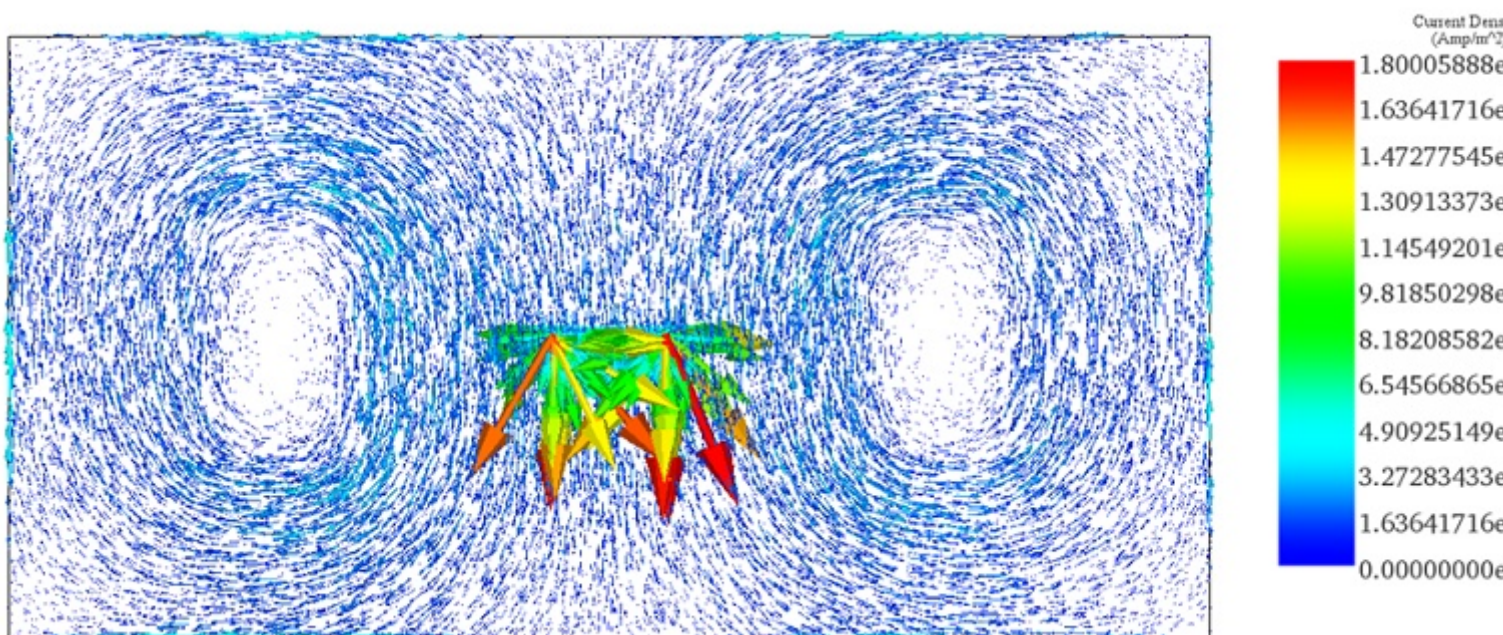
After 500 ms of induction heating, the simulation revealed significant findings. The current density distribution around the crack on the specimen surface displayed a clear perturbation of eddy currents, reaching maximum intensity around the endpoints of the detected defect. The altered flow directions of currents induced by the crack resulted in uneven heating of the surface.

Figure 4 - Vector plot of current density distribution

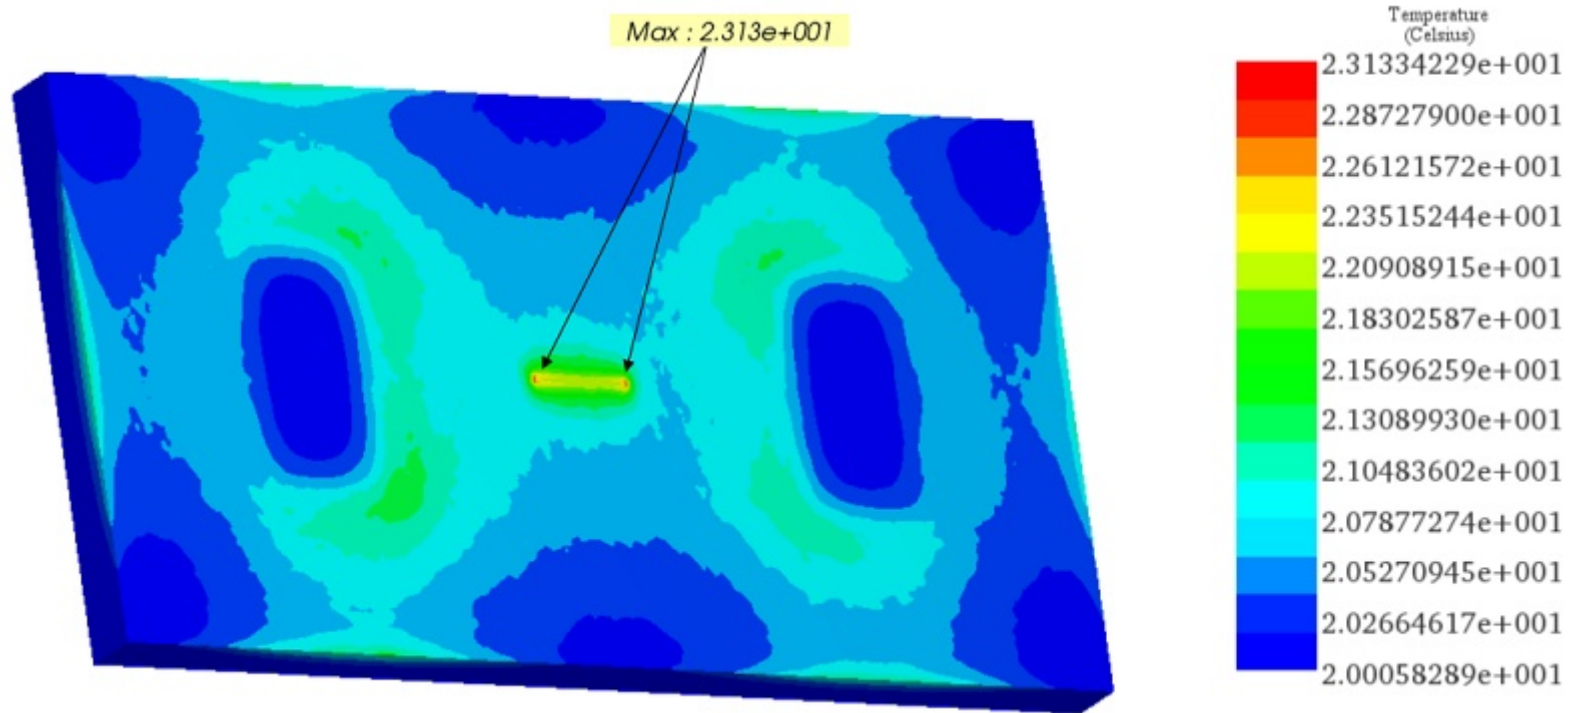
The induced temperature distribution is depicted in Figure 5. Across the central region of the U-shaped core on the specimen, the temperature appears to be evenly distributed. The maximum temperature is observed at the contours of the crack, reaching 23.13 °C, aligning well with the results reported in Reference [1].

Figure 5 - Temperature distribution
